Subject: Technical Report Addressing Historical Channel Position of Big Sandy Creek

# ***Draft* Geomorphic and Hydrologic Assessment of the Historic Channel Position of Big Sandy Creek through Sand Creek Massacre National Historic Site, Colorado.**

## ***Evaluation of possible channel shift over the last 150 years***

Natural Resource Technical Report NPS/NRPC/WRD/NRTR—2012/xxx

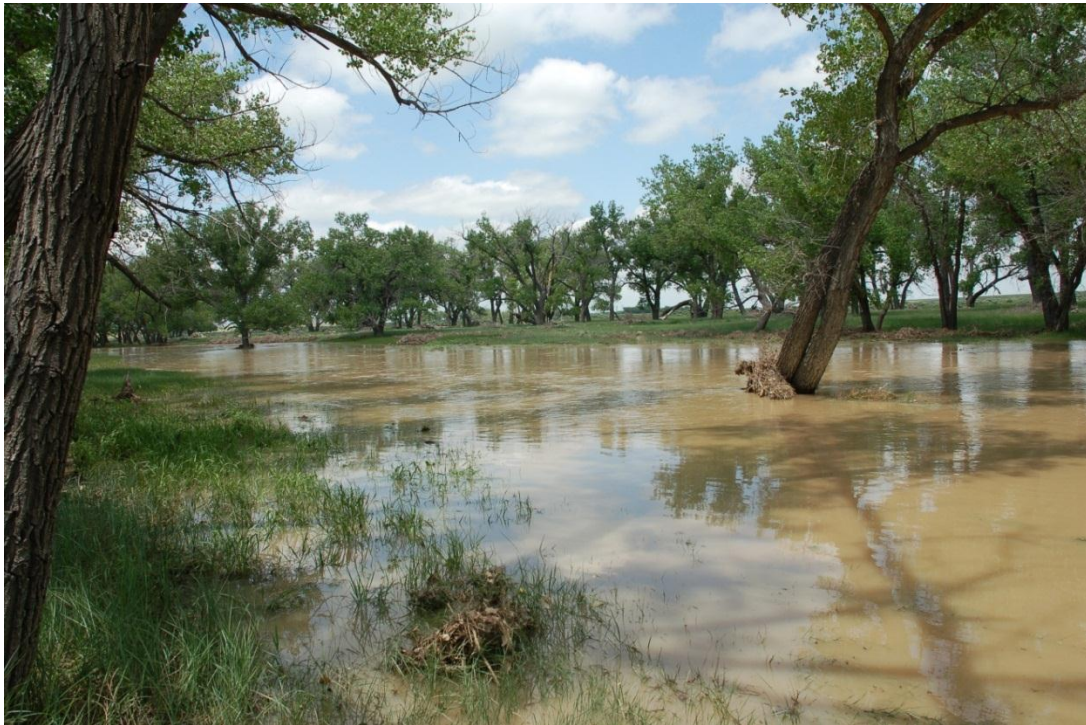
**Figure 3** – Big Sandy Creek during the storm flow of May 2007. This flow level essentially inundates the modern floodplain but not the low terrace, which is visible on the opposite side of the creek. Photo is taken from near the edge of the low terrace. Note the presence of cottonwoods on the low terrace and the modern floodplain. A portion of the intermediate terrace is visible as a relatively flat horizon in the distant center-right of the photo. NPS, 2007.
